Contract #: 04-0120F4Cty: SF/ALA Rte: 80 PM: 13.2/13.9File #: 13.28**WELDING INSPECTION REPORT****Resident Engineer:**Pursell, Gary**Address:** 333 Burma Road**City:** Oakland, CA 94607**Report No:** WIR-012314**Date Inspected:** 01-Mar-2010**Project Name:** SAS Superstructure**OSM Arrival Time:** 700**Prime Contractor:** American Bridge/Fluor Enterprises, a JV**OSM Departure Time:** 1730**Contractor:** Oregon Iron Works Clackamas, Or.**Location:** Clackamas.OR**CWI Name:** Jose Salazar**CWI Present:** Yes No**Inspected CWI report:** Yes No N/A**Rod Oven in Use:** Yes No N/A**Electrode to specification:** Yes No N/A**Weld Procedures Followed:** Yes No N/A**Qualified Welders:** Yes No N/A**Verified Joint Fit-up:** Yes No N/A**Approved Drawings:** Yes No N/A**Approved WPS:** Yes No N/A**Delayed / Cancelled:** Yes No N/A**Bridge No:** 34-0006**Component:** Hinge K**Summary of Items Observed:**

Hinge-K Pipe Beam Assembly 102A-2:

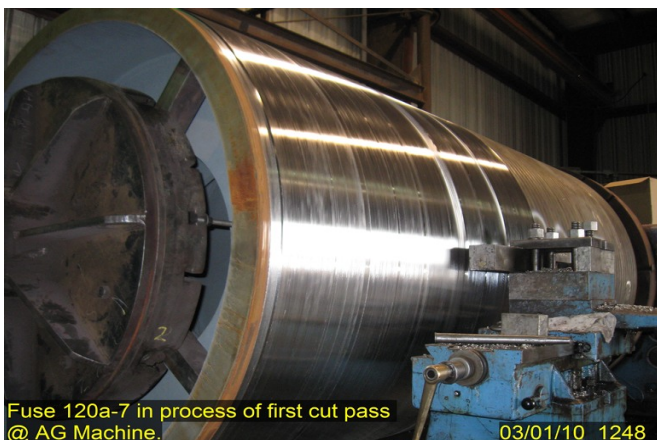
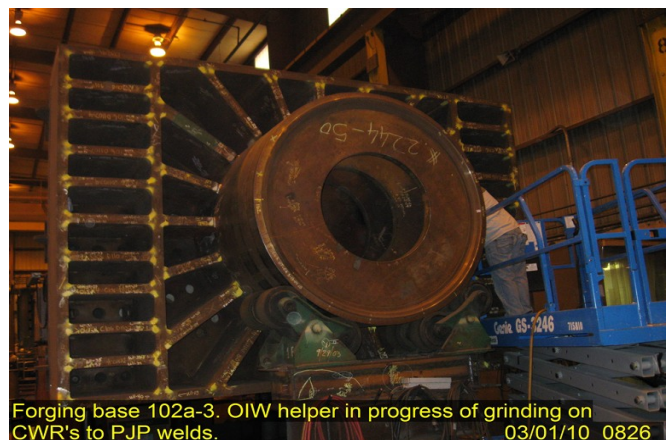
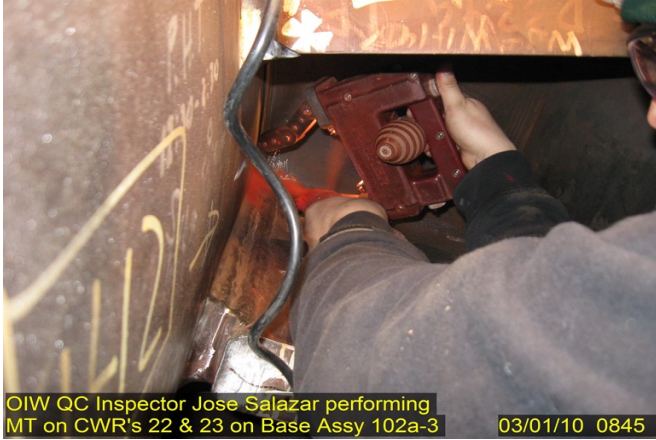
(See attached photos)

OIW Quality Control (QC) Inspector Jose Salazar informed the QA Inspector that OIW have completed Critical Weld Repairs (CWR) # 023 & #24. OIW had received a verbal approval to proceed with CWR's 022 and 023 on 2/26/10. The repair welding was completed on the evening of 2/26/10. The weld joint designations for the CWR's were listed as #142 & #145. The QA Inspector observed OIW Leadman Troy Smith in the process of cleaning weld terminations on stiffener to forging locations. The QA Inspector later observed that QC Inspector Salazar was present to perform Magnetic Particle Testing (MT) on the CWR's. The MT was being performed after 48 hrs cooling period as described in AWS D1.5- 02 Sec.12.16.4(FCP). The QA Inspector observed that the MT was performed per OIW approved procedure, QC-113, Rev. #3. QC Inspector Salazar stated that no rejectable indications were discovered during the testing. OIW Leadman Troy Smith informed the QA Inspector that this assembly would be moved out of the welding manipulator and placed on the lathe for further machining of stiffeners within the next couple of days.

(SAW) on the a109 Cap plate to a106 HPS 485W stiffener base. The QA Inspector noted that this weld joint was designated as a partial joint penetration (AWS D1.5 TC-P4-S), weld joint #W2-19. Mr. Belgrade was performing the SAW in the flat (1G) position using OIW approved welding procedure specification (WPS 4020). The QA Inspector observed QC Inspector Jose Salazar verifying the in-process welding parameters and pre-heat temperature. The QC Inspector stated the average welding parameters were observed at 598 amps and 35 volts with a pre-heat temperature of 350 degrees Fahrenheit (177 C). The QA Inspector also verified the welding parameters and pre-heat. Items observed appeared to in general compliance with the AWS D1.5 and the applicable WPS (4020).

The QA Inspector arrived at AG Machine Works to observe the final machining on the Fuse 120A-7. The QA Inspector met with AG Machinist Stuart Doyle. Mr. Doyle explained that he was currently in process on the first final machining cut pass. Mr. Doyle explained that this cut pass is set to remove approximately 5 mm of stainless steel overlay material. Mr. Doyle further stated that AG would possibly complete the first cut on 3/2/10 & go into the third cut by the end of the week. (Per the contract requirements a finished outer diameter of 1920 mm (+/- 1 mm) is required.) The Machinists did not think that final inspection would take place this week. The QA Inspector also noted that this Fuse is the first of the "Spare" fuses to go through the final machining process. Mr. Doyle stated that he was not instructed to machine a bevel prep on the Fuse. The QA Inspector inquired if the ends of the Fuse would be machined /"faced". Mr. Doyle was unsure but stated that he would inquire with OIW Project Manager Bill Pender. Currently the untrimmed end of this spare Fuse is in the flame cut condition.
